### Car Details

Customer/Dealer Name	Engine Capacity 1480 cc	Last Mileage 36178 km	Fuel Type Petrol
Inspection Date 24 Sep 2024	Make	Engine	VIN No
Made In USA	Registered City Washington	Transmission Type Automatic	Color Grey

Car Inspection Report -

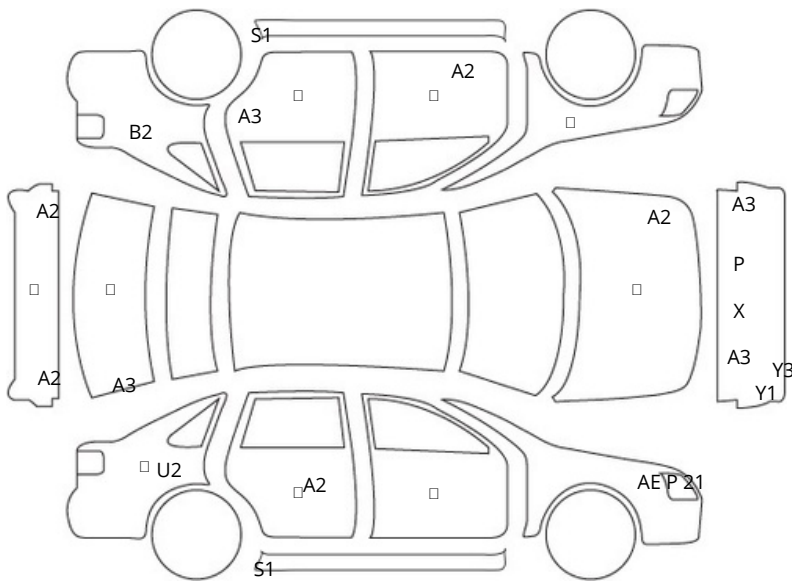
## Exterior Condition
